Intel[®] StrongARM^{*} SA-1111 Microprocessor Companion Chip

Specification Update

May 2002

Order Number: 278260-013

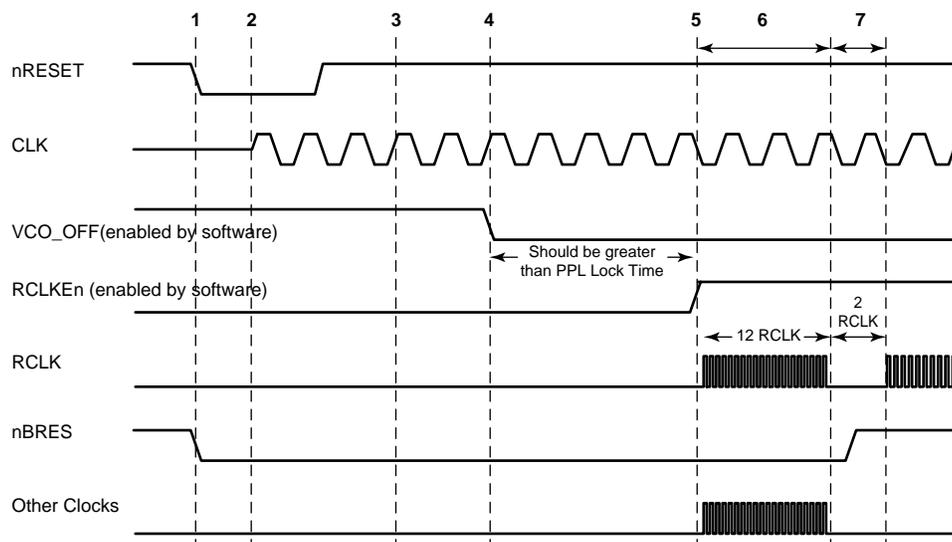
Figure 2-2. SA-1111 Reset Sequence

Changed VCO_On to VCO_Off and the signal in Figure 2-2. Figure 2-2 now appears as follows:

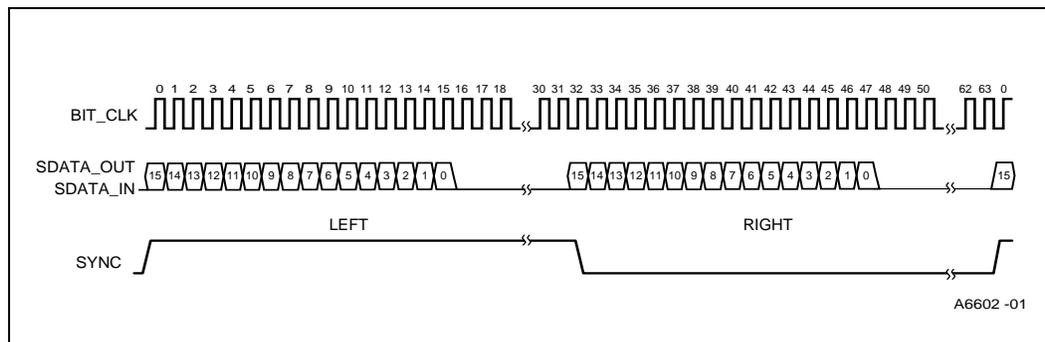
Figure 7-4. MSB-Justified Data Formats (16 bits):

Update Figure 7-4 MSB-Justified Data Formats (16-bits). Figure 7-4 now appears as follows:
